PROJECT DIAMOND ORE; PHASE IIA:
EFFECTIVENESS OF CRATERS AS BARRIERS TO MOBILITY

Army Engineer Waterways Experiment Station
Vicksburg, Mississippi

May 1973

MISCELLANEOUS PAPER M-73-6

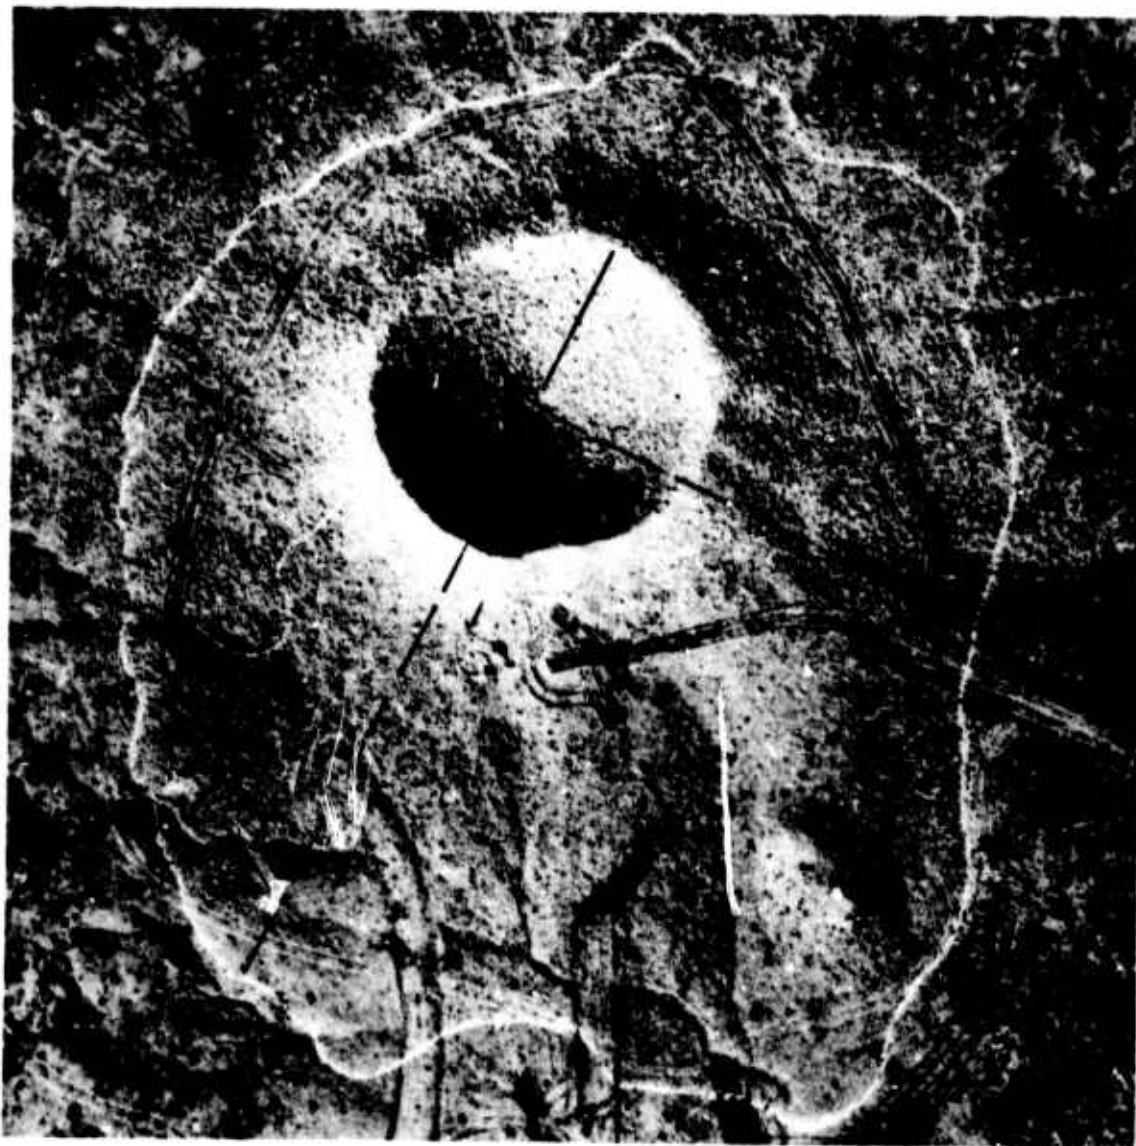
Figure 2.3 Aerial photograph of crater IIA-1; dashed lines indicate location of elevation profiles shown in Figure 3.2.

2.4.1 Surface Configuration. To characterize the craters, profiles for each crater elevation were measured along and perpendicular to crater radii by standard surveying techniques. The approximate locations of these profiles are shown by the dashed lines in figures 2.3, 2.4, and 2.5.

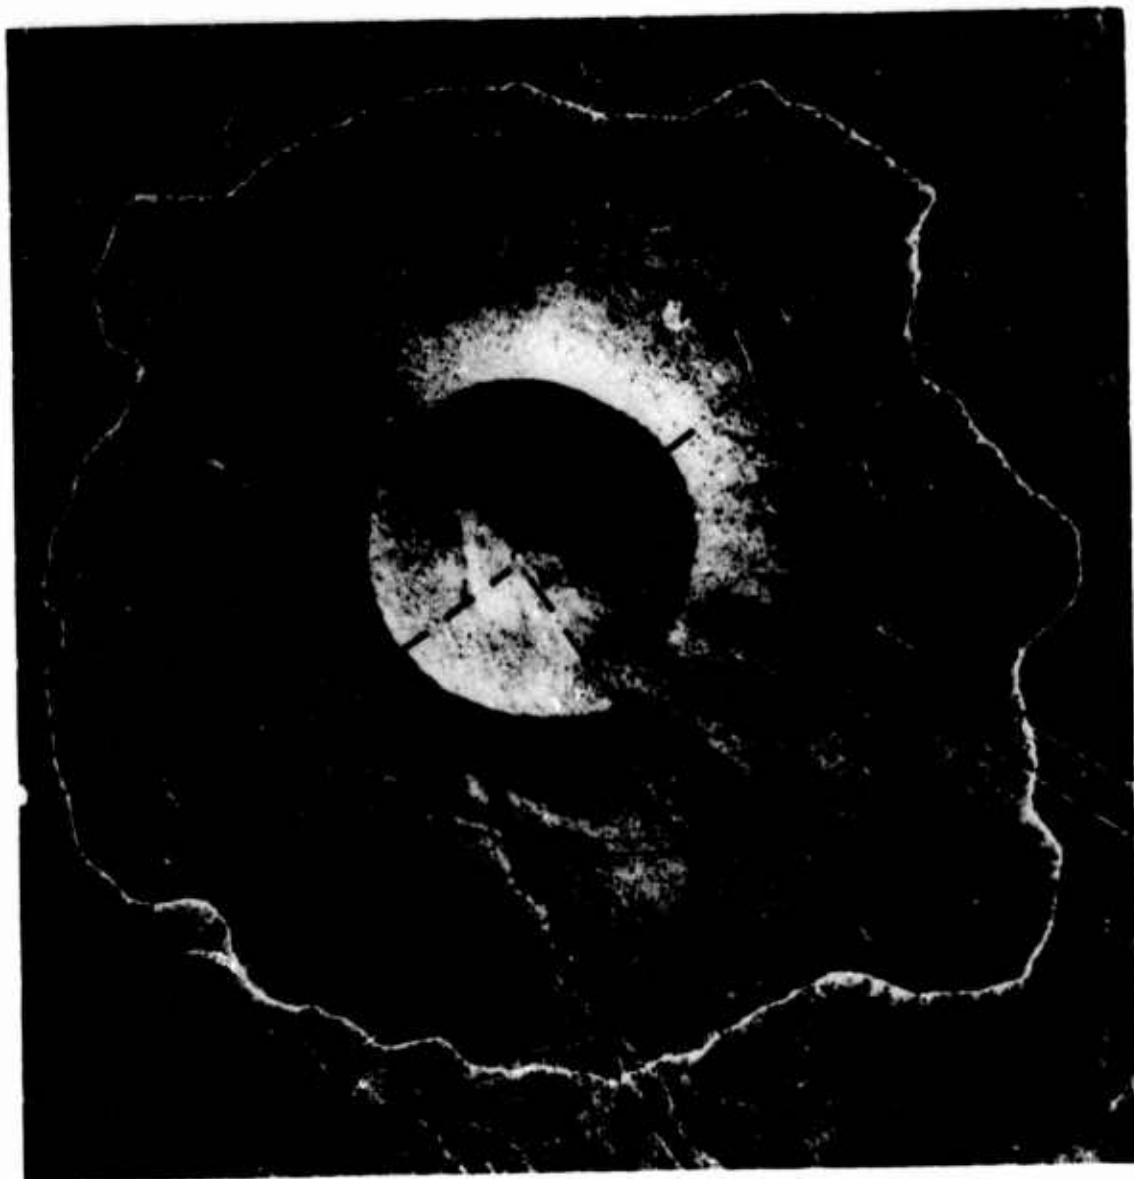
Figure 2.4 Aerial photograph of crater IIA-2; dashed lines indicate location of elevation profiles shown in Figure 3.3.

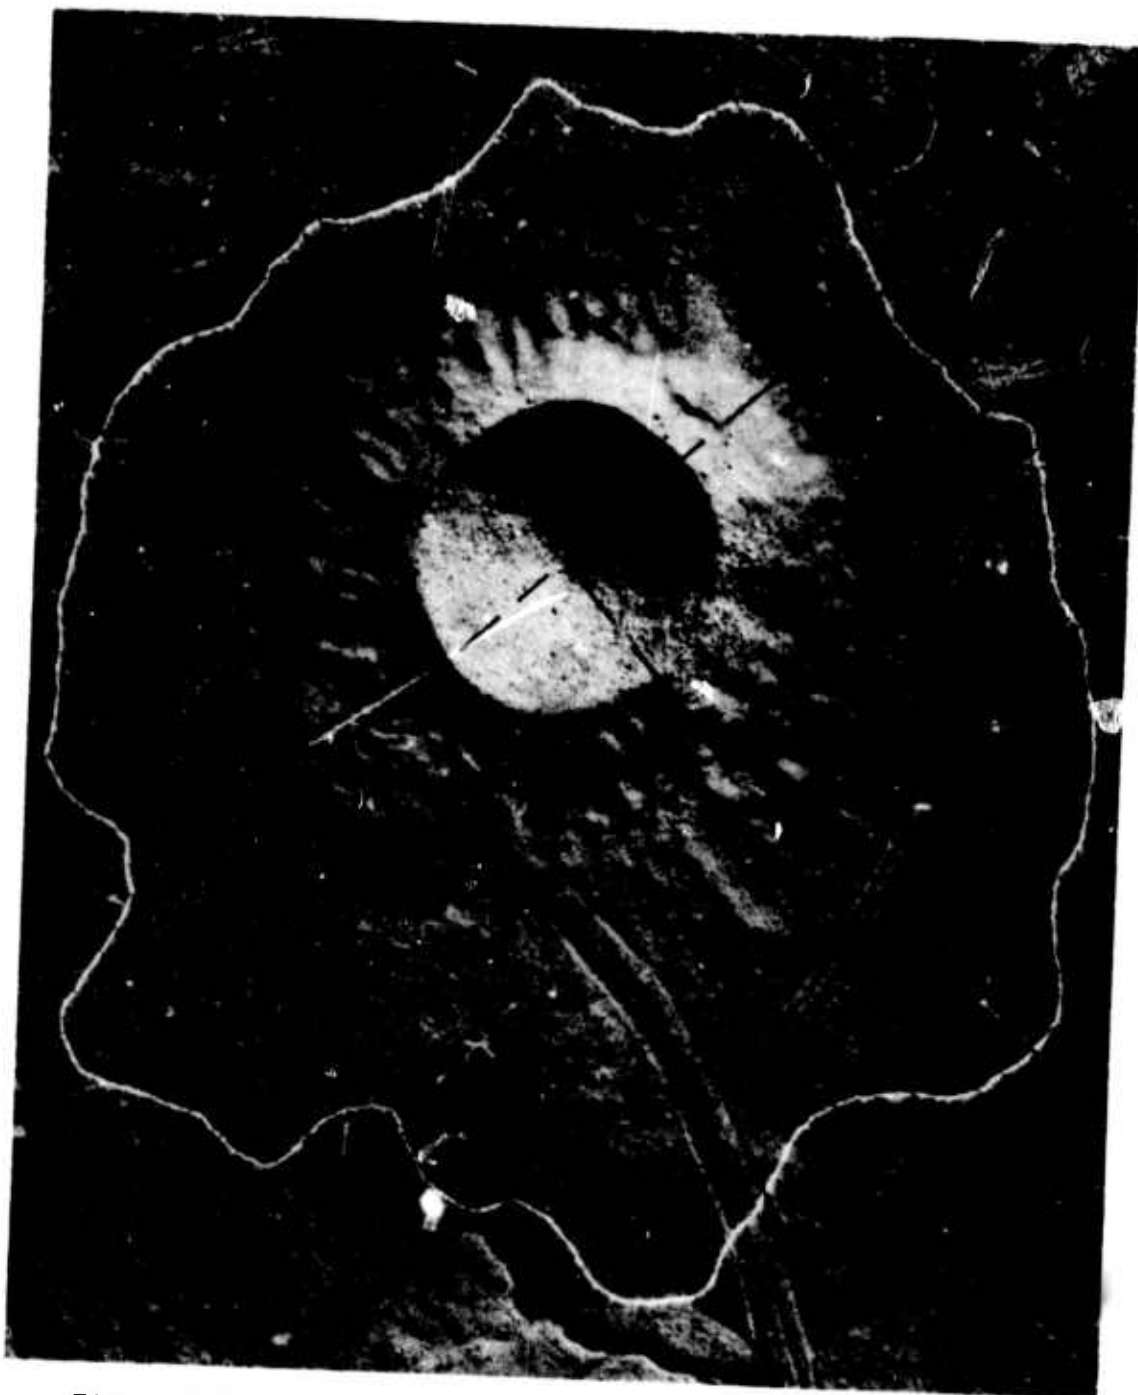
Figure 2.5 Aerial photograph of crater IIA-3; dashed lines indicate location of elevation profiles shown in Figure 3.4.

The test area was located on the Fort Peck Reservoir reservation south of Glasgow, Montana (see vicinity map, Figure 2.1). Three craters were formed in October 1972 by the detonation of 10-ton charges of aluminized ammonium nitrate slurry (equivalent to 16 tons of TNT). The specific locations of the three craters are shown in Figure 2.2. The craters are identified as IIA-1, IIA-2, and IIA-3. Crater IIA-1 (Figure 2.3) was formed by an unstemmed charge placed at optimum depth of burst (DOB = 41.1 feet), crater IIA-2 (Figure 2.4) by a fully stemmed charge placed at optimum DOB, and crater IIA-3 (Figure 2.5) by a fully stemmed charge at a 6-m (19.68 ft) DOB.

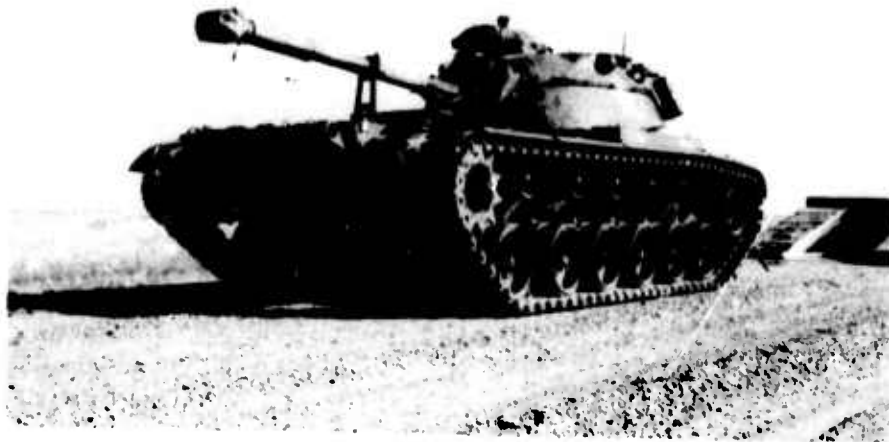
Fig. 2.7 M48A2 tank.

The test vehicle was an M48A2 tank (Figure 2.7) furnished by the Montana National Guard Unit at Glasgow, Montana. Engineering data pertinent to this study are given in the following tabulation:

Gross vehicle weight, pounds	98,000
Track	
Contact length, inches	164
Width, inches	28
Shoe, inches	7
Bogies on ground, per side	6
Ground clearance, inches	19
Engine type	Gasoline
Brake horsepower	810
Transmission	Automatic

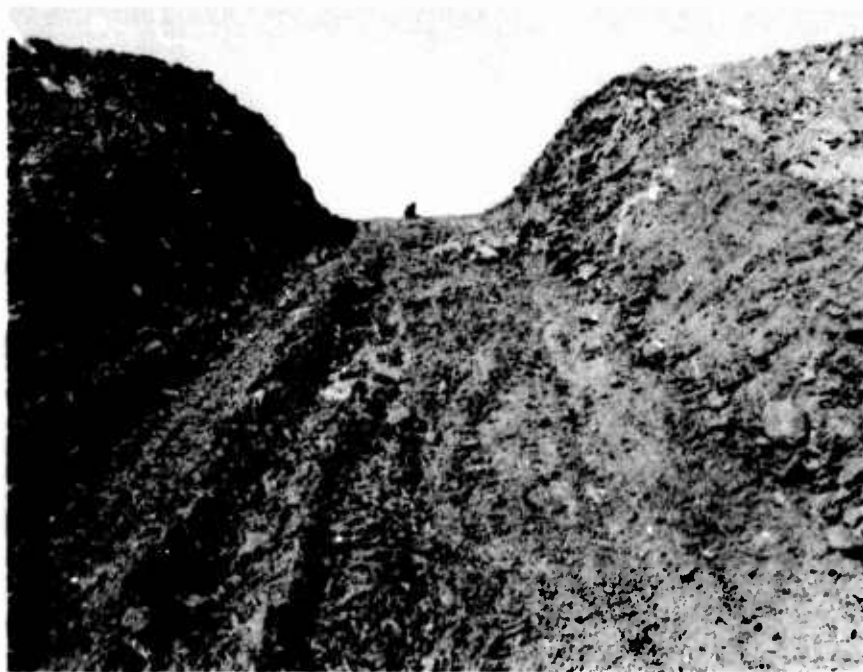
Figure 3.9 Entrance to crater IIA-3 as constructed by D9 tractor.

3.2.3 Crater IIA-3. The tank had no difficulty entering the crater, but could climb only about one-half the way up the wall when attempting to exit. The D-9 tractor was used to determine the amount of construction effort required to make the crater passable for the tank. To simulate a tactical condition, the tractor bulldozed an entrance through the lip (see Figure 3.9). This served several purposes. It provided a sure way for the tank to climb out of the crater in the event the tractor might have been unable to backblade an exit, and the material pushed down into the bottom of the crater gave the tractor a higher point of attack on the opposite slope. Twenty-seven minutes were required to construct the entrance; 14 minutes were used to backblade an exit on the opposite slope (Figure 3.10). Approximately 250 cubic yards of soil were moved. Then the tank was able to exit the crater after 12 attempts (9 minutes). An elevation profile showing the results of the construction effort graphically is given in Figure 3.11. It was considered that this crater would require 1 bulldozer-hour of construction effort for it to be made passable for virtually any off-road military vehicle.

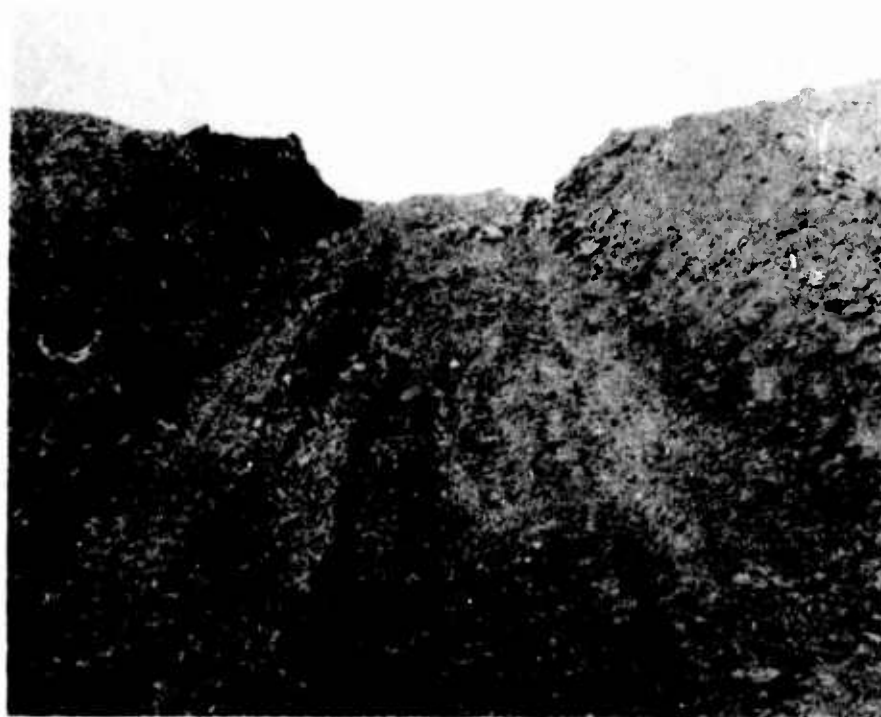
Figure 3.10 Exit from crater IIA-3 as constructed
by D9 tractor.
